TECHNICAL REPORT CERC-85-10

# WAVE STABILITY TESTS OF DOLOS AND STONE REHABILITATION DESIGNS FOR THE EAST BREAKWATER, CLEVELAND HARBOR, OHIO

Experimental Model Investigation

Coastal Engineering Research Center

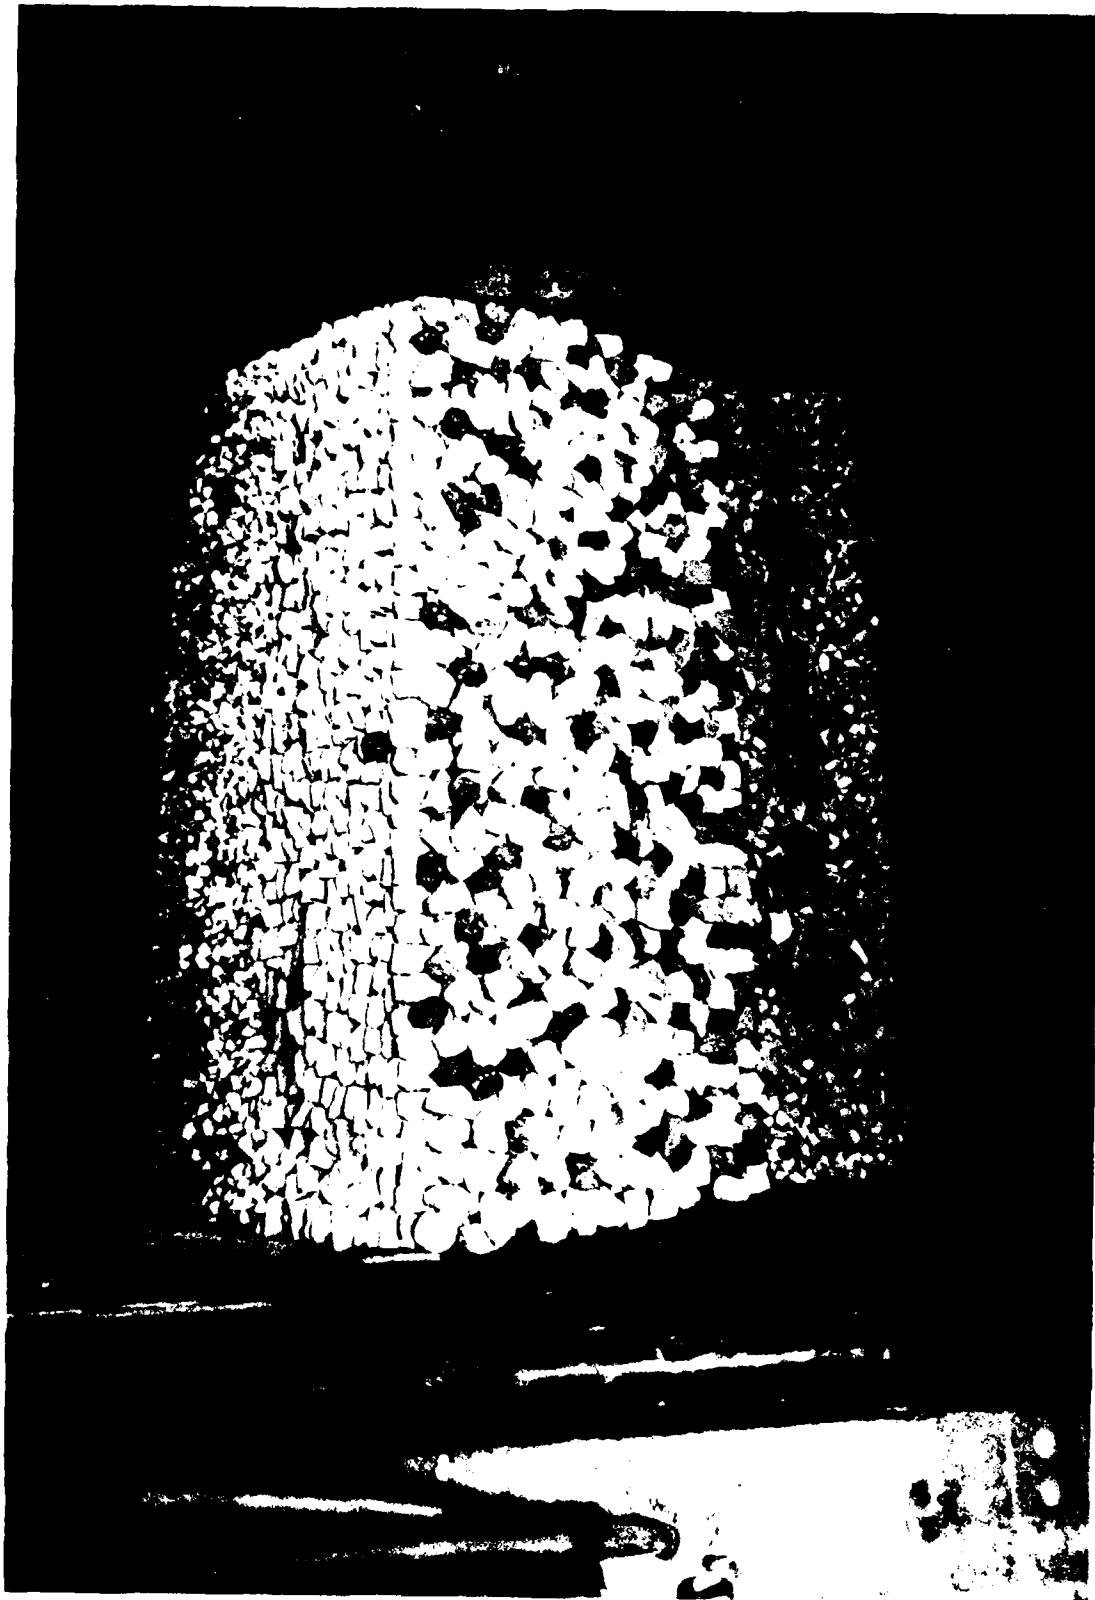
Photo 41. Lakeside view of Plan 3 after testing Hydrograph A, second test section

27. The 9- to 20-ton armor stone was rebuilt (Photos 38-40) and Plan 3 was once again exposed to Hydrograph A. The structure accrued less damage during this testing. Three armor stones were displaced (two on the crown and one at the swl on the lakeside slope) during Steps 1 and 2. No displacement occurred during Step 3, but two armor stones on the crown and three at the swl continued to show minor to significant in-place rocking and reorientation throughout the test. Photos 41-43 show that the structure was in good condition (slight spot damage on crown and around swl) at the end of the test.

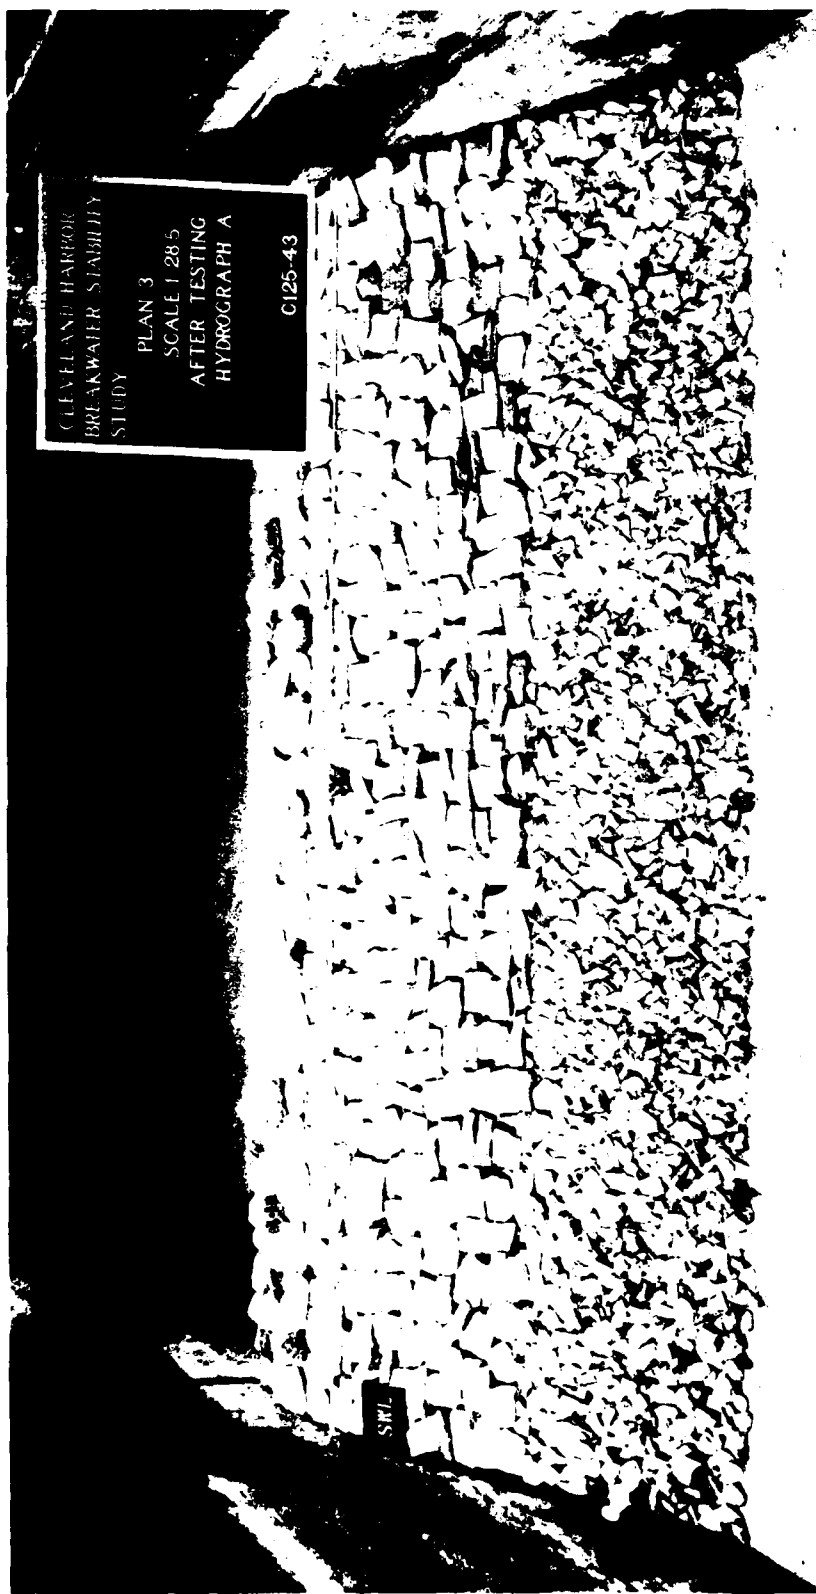
Photo 42. Overhead view of Plan 3 after testing Hydrograph A,  
second test section
